Photo No. 1: Rear of Titan Trackmobile; fire damage to cab

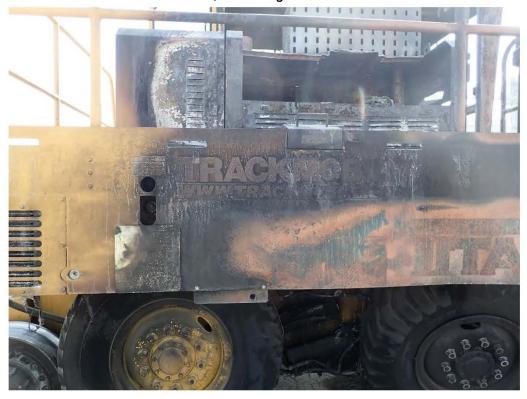
Photo No. 2: Right side of Trackmobile; side where diesel engine is located

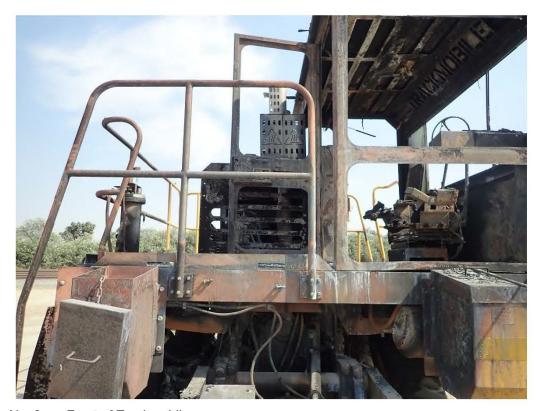
Photo No. 3: Front of Trackmobile

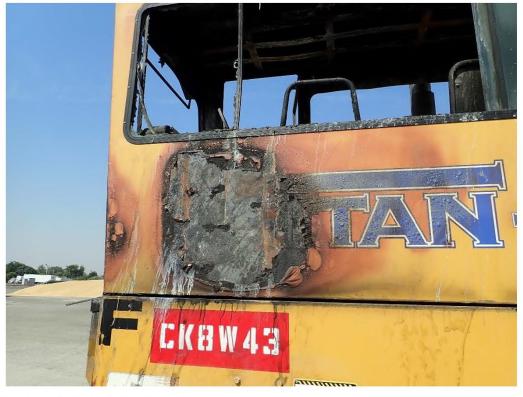
Photo No. 4: Left side of trackmobile

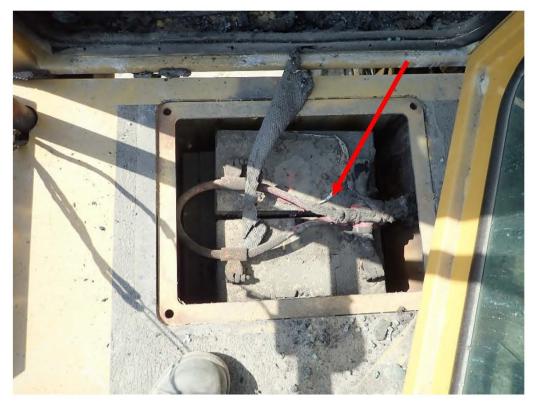
Photo No. 5: Battery box for Trackmobile; inside rear step; no arcing; batteries & connections intact

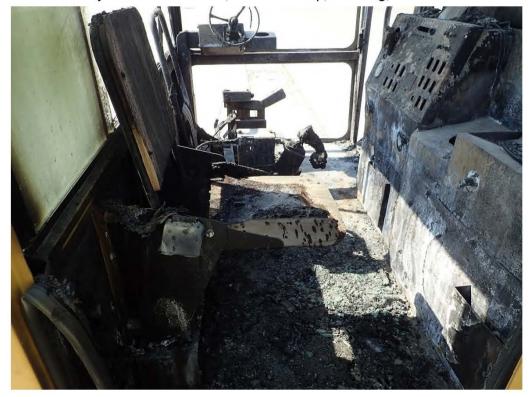
Photo No. 6: Fire damage to cab area of Trackmobile

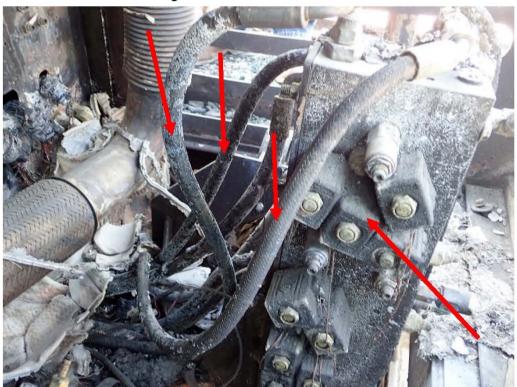
Photo No. 8: Hydraulic lines from Hydraulic Valve Block where operator controls engine remotely

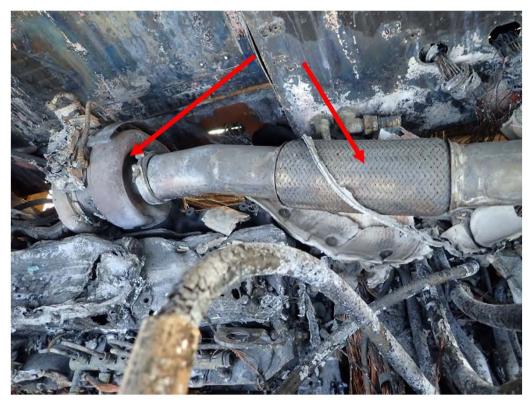
Photo No. 9: Diesel engine's turbo charger & exhaust assembly; area of fire origin

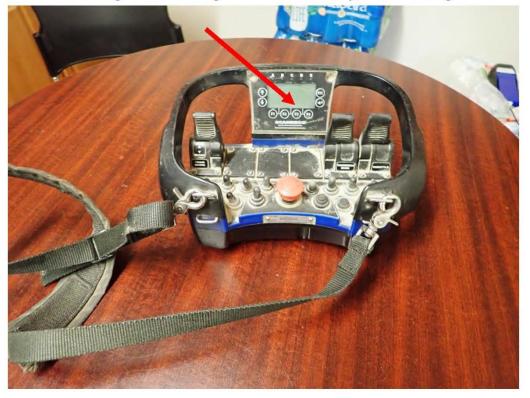
Photo No. 10: Scanreco radio remote control used on Trackmobile prior to fire

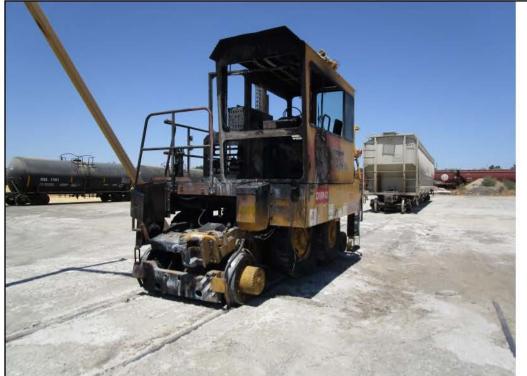
PHOTO #3

Rear Rt Overall View

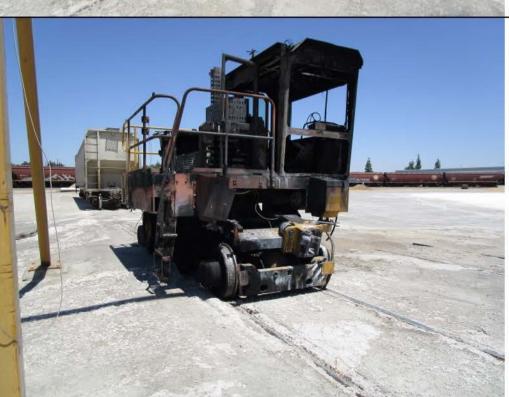
PHOTO #4

Rear Lt Overall View

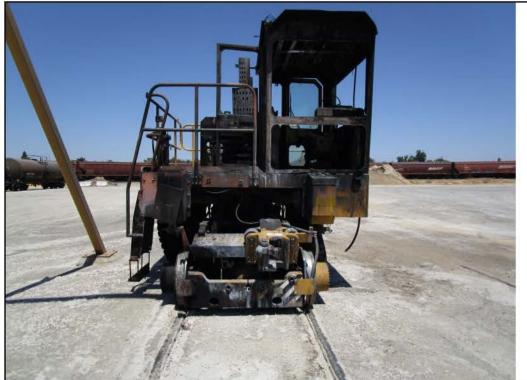
PHOTO # 9

Rear View Of Damage

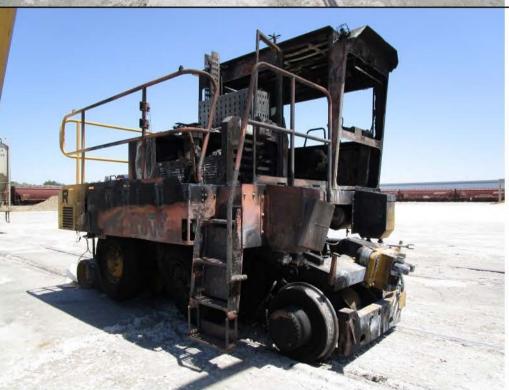
PHOTO #10

View Of Lt Side Damage

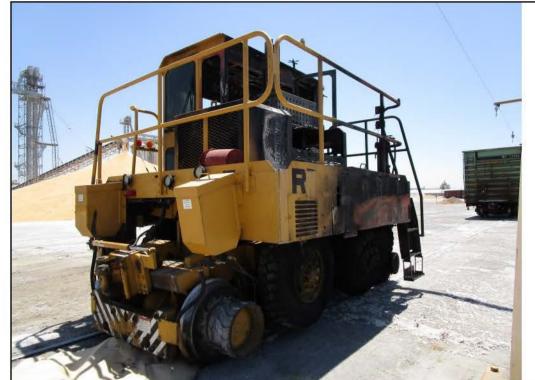
PHOTO #11

View Of Lt Side Damage

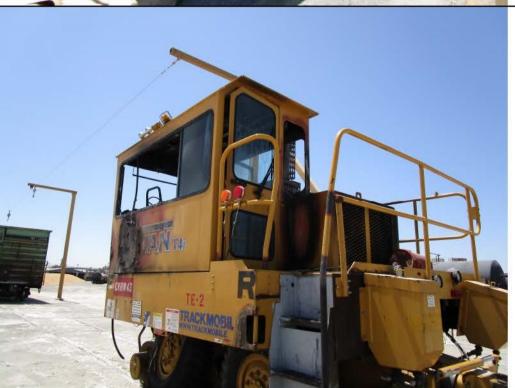
PHOTO # 12

View Of Rt Side Damage

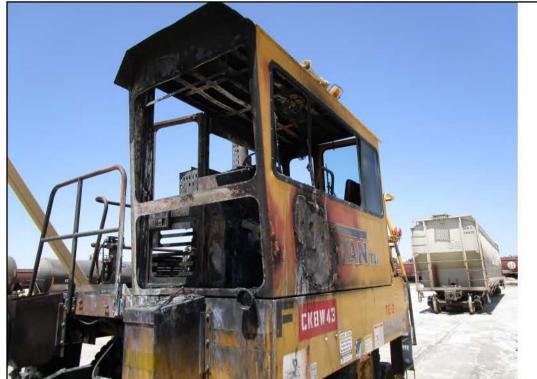
PHOTO # 13

View Of Rt Side Damage

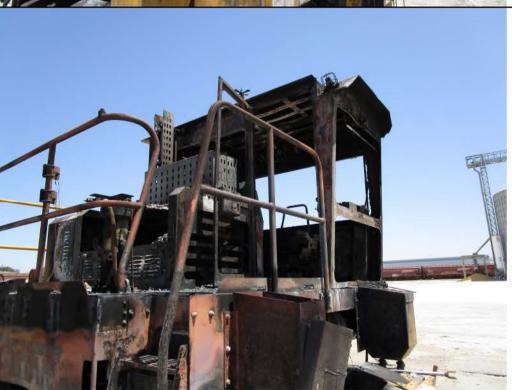
PHOTO #14

View Of Cab Damage

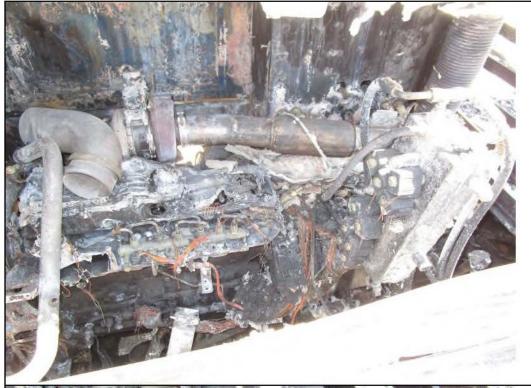
PHOTO # 23

View Of Damaged Engine

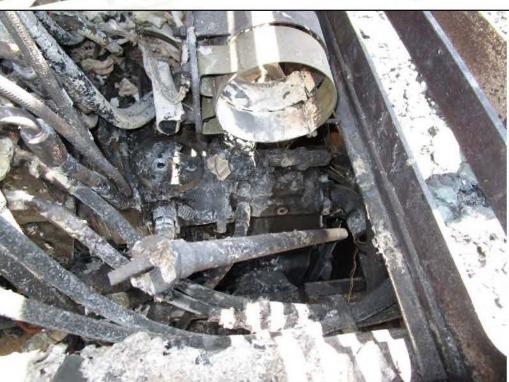
PHOTO #24

View Of Damaged Hydraulic Pump & Lines
