GP 40 Locomotive #4505

Inspection Report

WORK SCOPE FOR IDAHO NORTHERN & PACIFIC LOCOMOTIVES

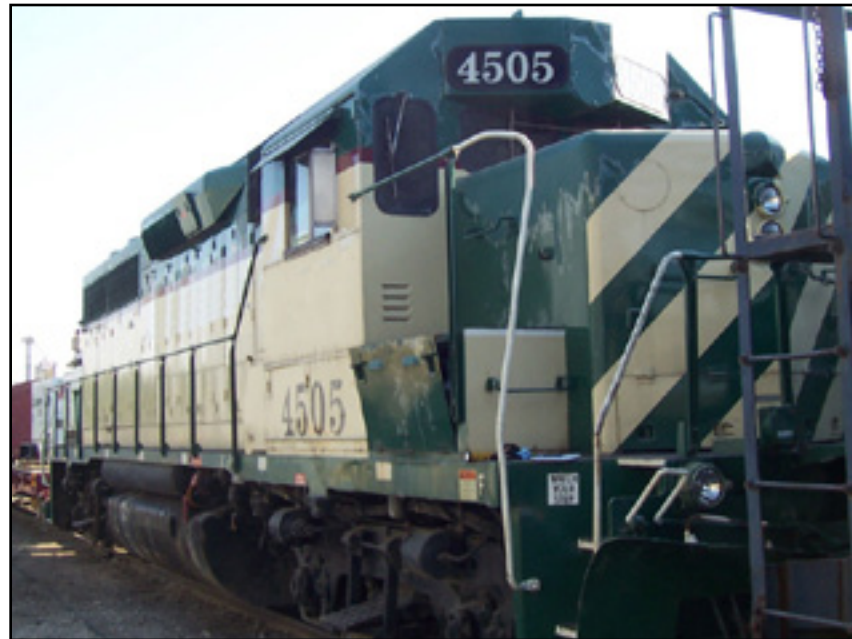
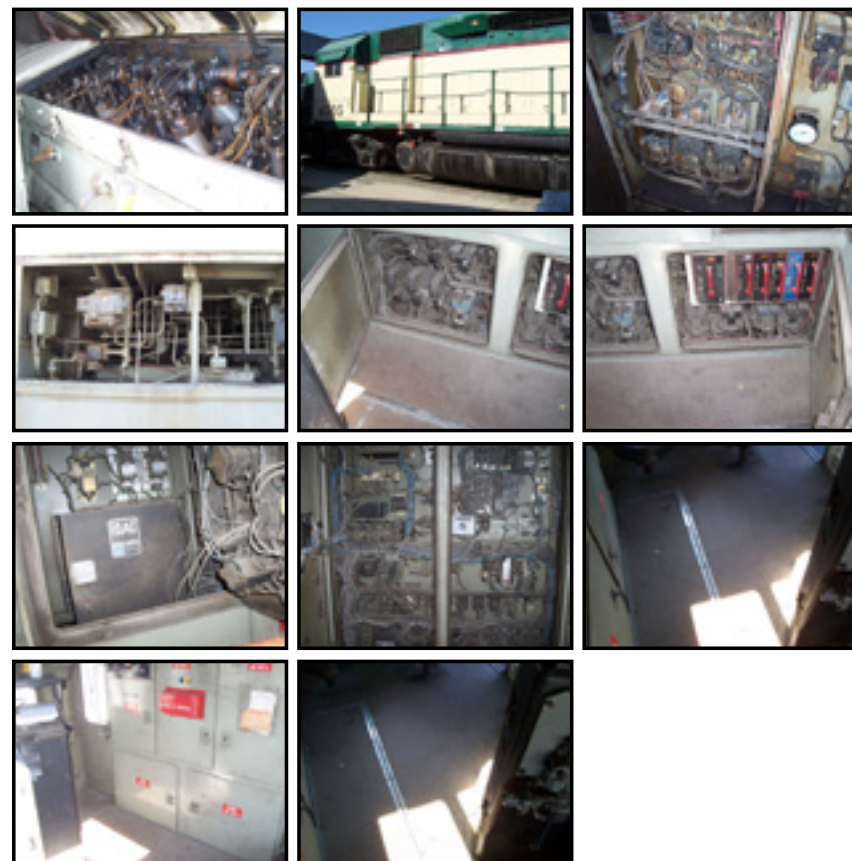
- Car body is in good shape clear coat is peeling
- Cab has good flooring
- All glass good
- Electrical cabinet has had some exaine wiring done in past IN&P call it good running condition

- No missing parts • Unit has traction motor cut outs
- Note this cabinet is dirty like the others needs blowing out
- Control stand -- nothing missing
- 4 batteries missing the others are very dirty and corroding

- Brakeman heater is missing
- Rear covers of electrical cabinet all loose
- Engine air filters are very dirty
- AR10 looks to be in shape, was replaced 2000

- Engine looks to be shut down running and top deck and air box are not very dirty. #10 crankcase cover missing. New Injectors and valve bridges and Turbo 3/2006

- No large oil leaks could be seen, No Crankcase damage
- AC cabinet wiring not to bad for age and needs cleaning rear sander magnet valve missing
- Hot Start is missing

- Radiators have no visual signs of leaks, but hard to tell after 2 years in storage. They need to be pressure washed very dirty. Fans all turn freely
- Dynamic Brake grids all look ok and fan turns freely. Has extended range DB

- 10 KW aux gen
- G.D. WBO deep sump air compressor Poor condition per IN&P
- Trucks look ok will need some brake shoes replaced before shipping
- Wheels have no thin flanges or high flanges and unit can be shipped as is, 2 new wheel sets 2004 and the others 2005 and one traction motor

- Unit has self aligning couplers
- Horn has been removed crossing bell in place
- Engine serial # 65-12-1135 16-567-D3A
- This engine was running TIER 2 when in service
